Original F-scale:**F5 Tornado Damage (Online Tornado FAQ)**

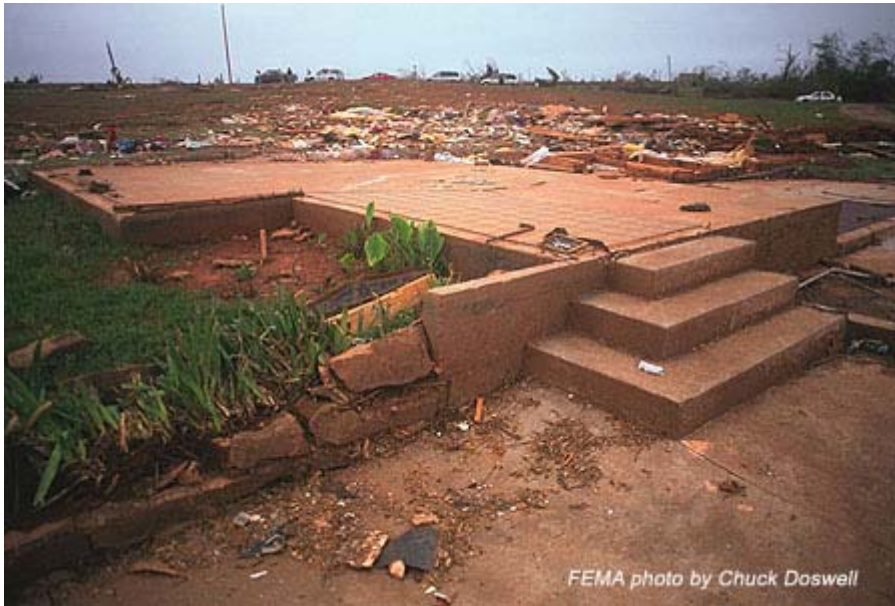
FEMA photo by Chuck Doswell

This is classic F5 damage. The Bridge Creek/Moore, Oklahoma, tornado of 3 May 1999 leveled this house, swept the foundation almost completely clean, shredded the house remains into small pieces and scattered the debris downwind to the northeast (rear). The house was relatively well-constructed with slab-to-wall anchor bolts evenly spaced around the bottom plate. Some of those bolts can be seen in this photo, protruding upward from just inside the edges of the concrete slab.
