**Original F-scale:
F2 Tornado Damage (Online
Tornado FAQ)**

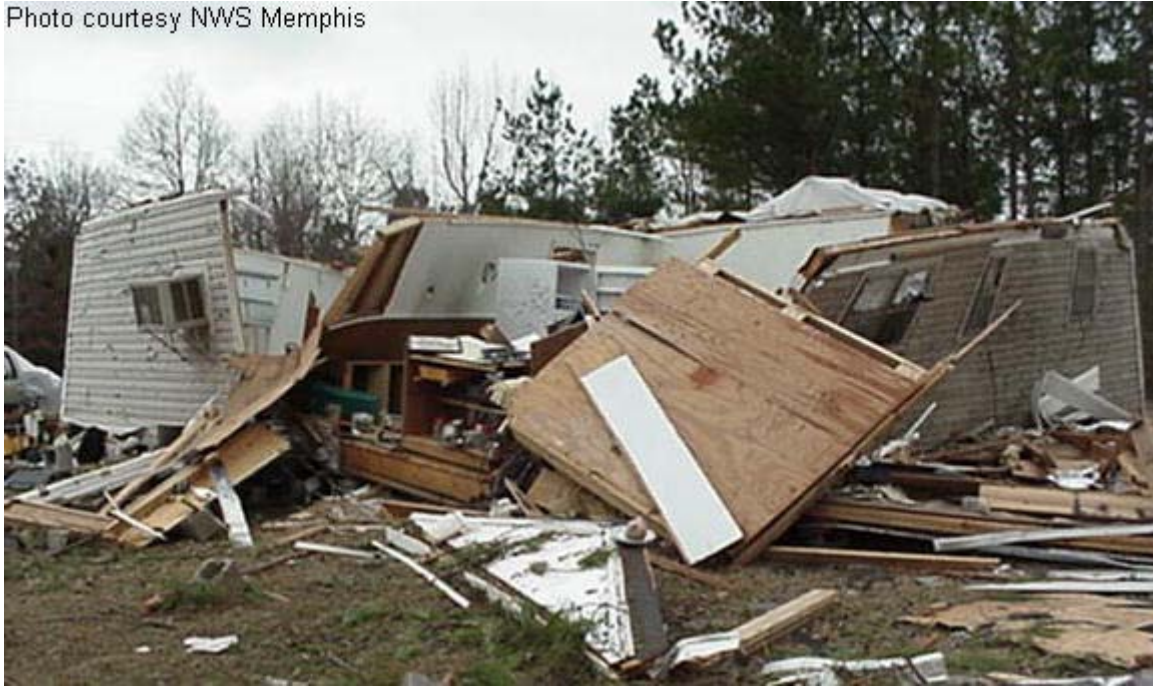
On 3 January 2000, a tornado struck this wood-frame home near Paris, MS. The roof and one large outer wall segment came off; while the remaining inner and outer walls were left (barely) standing. Quality of construction must be considered when rating damage; since the F scale is best applied to *well-built* homes. Here, the wall-to-roof and wall-to-wall attachments were very weak or nonexistent; so this is only marginal F2 damage.
