**Original F-scale:
F4 Tornado Damage
(Online Tornado FAQ)**

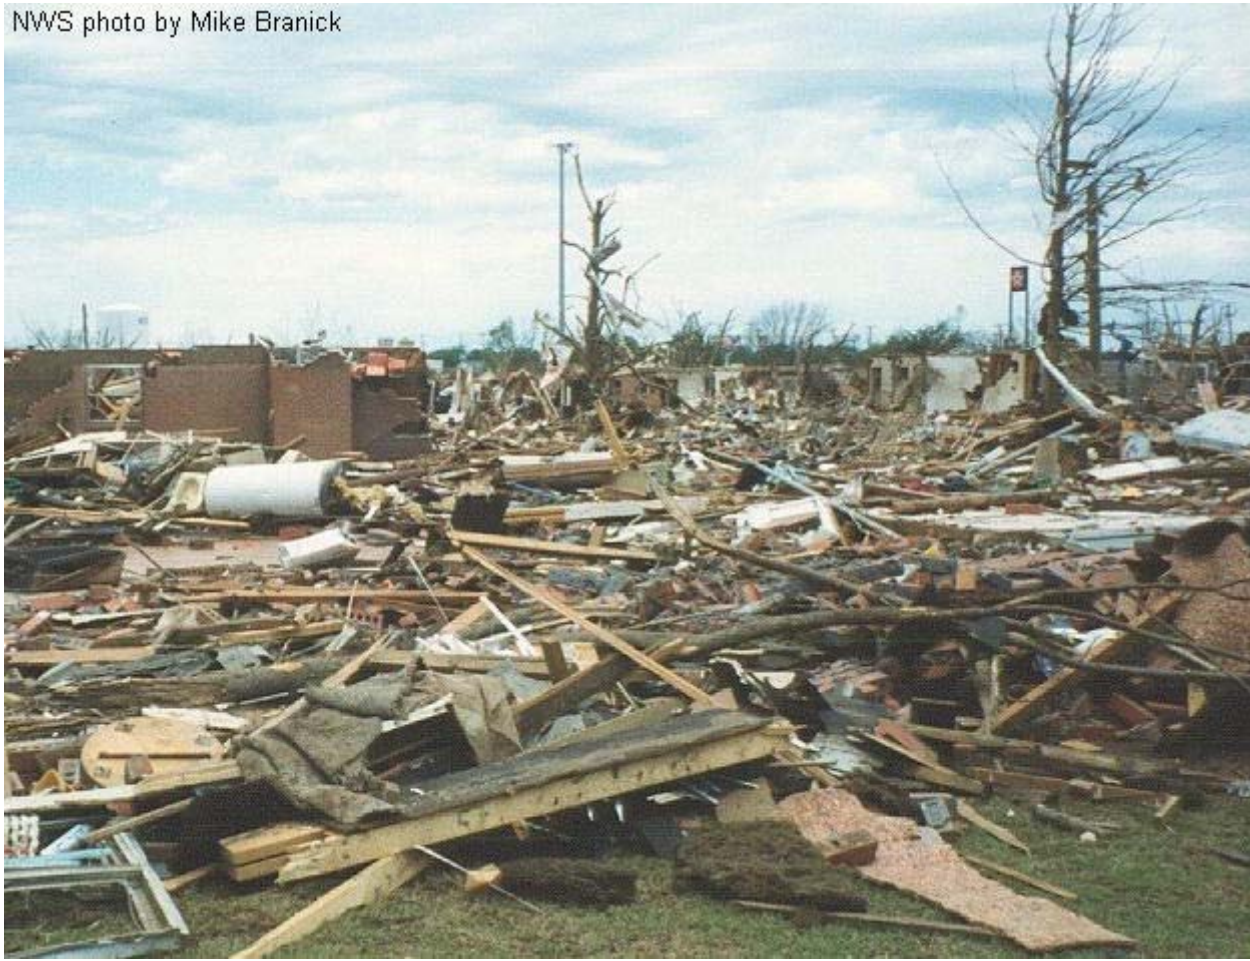
A tornado in Moore, OK on 3 May 1999 demolished this house (foreground) down to a short pile of debris on and around the foundation, with no walls standing. In order for this scene to be rated F5, the debris must have been swept away, leaving behind evidence that the house was well-attached to its slab. [The brick house in the left background suffered F3 damage, with a mixture of inner and outer walls removed.] This tornado caused an immense amount of F4 damage on its path through the southern portion of the Oklahoma City metropolitan area, and several locales of [F5](#) damage.
